**AE ASSOCIATES, INC.***Engineering Design • Project & Construction Management***BUILDING AND SPECIAL INSPECTIONS****ENVIRONMENTAL AUDIT - LEVEL 1****Client:** Mr. Robert Ball**Principal Contacts:** Mr. Ball, Tamara McDermott (Building Manager)**AE ASSOCIATES, Inc. Project # 95-357****Report date:** December 22, 1995
Updated December 28, 1995
Updated January 3, 1996**Property location:** Multnomah County
Tax description: R-18022-8460 per
County Record
Tax Lots 12 (partial), 13, 17, 18 of
Block 284, Map 2927,**Location:** 2083 NW Johnson Street
Portland, Oregon 97209**Description of property:**

REF:C:RPT95357

GENERAL SUMMARY

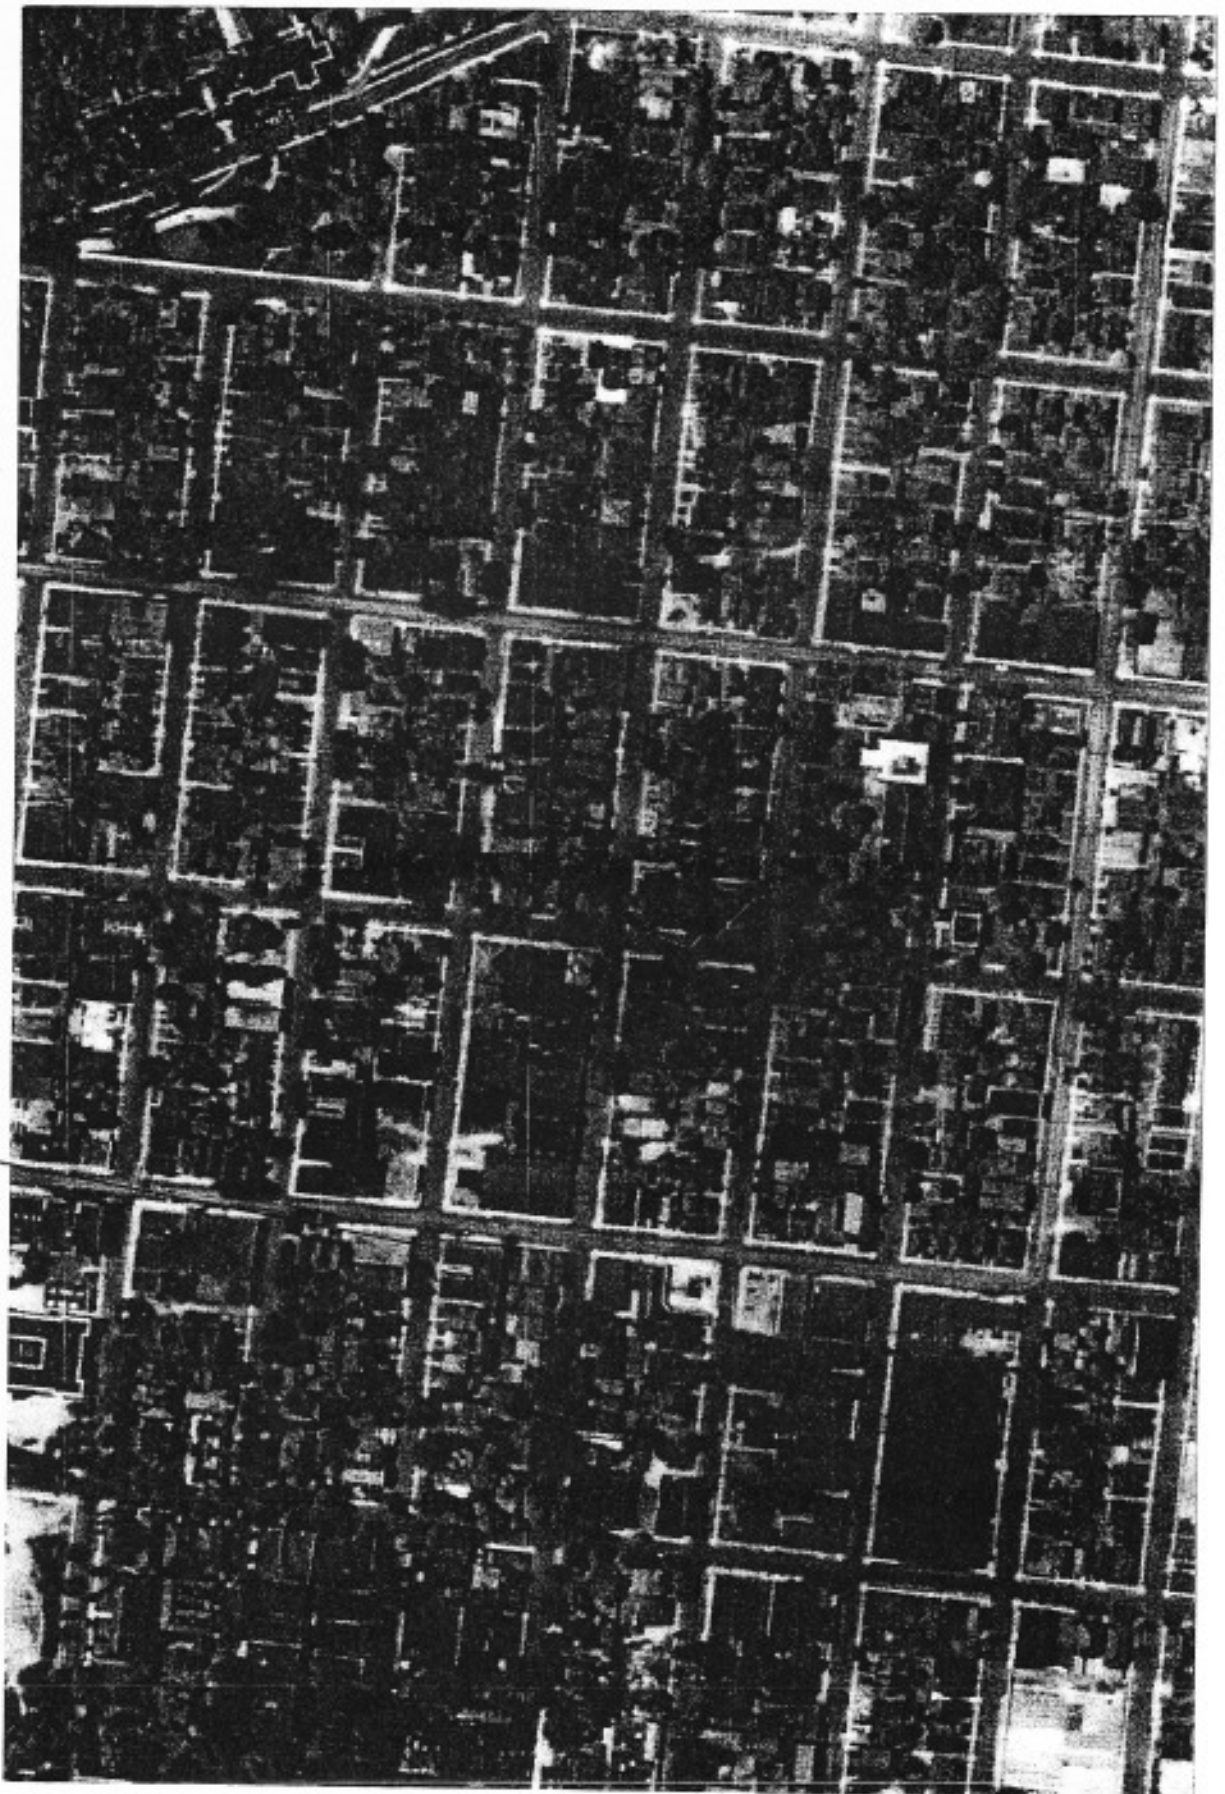
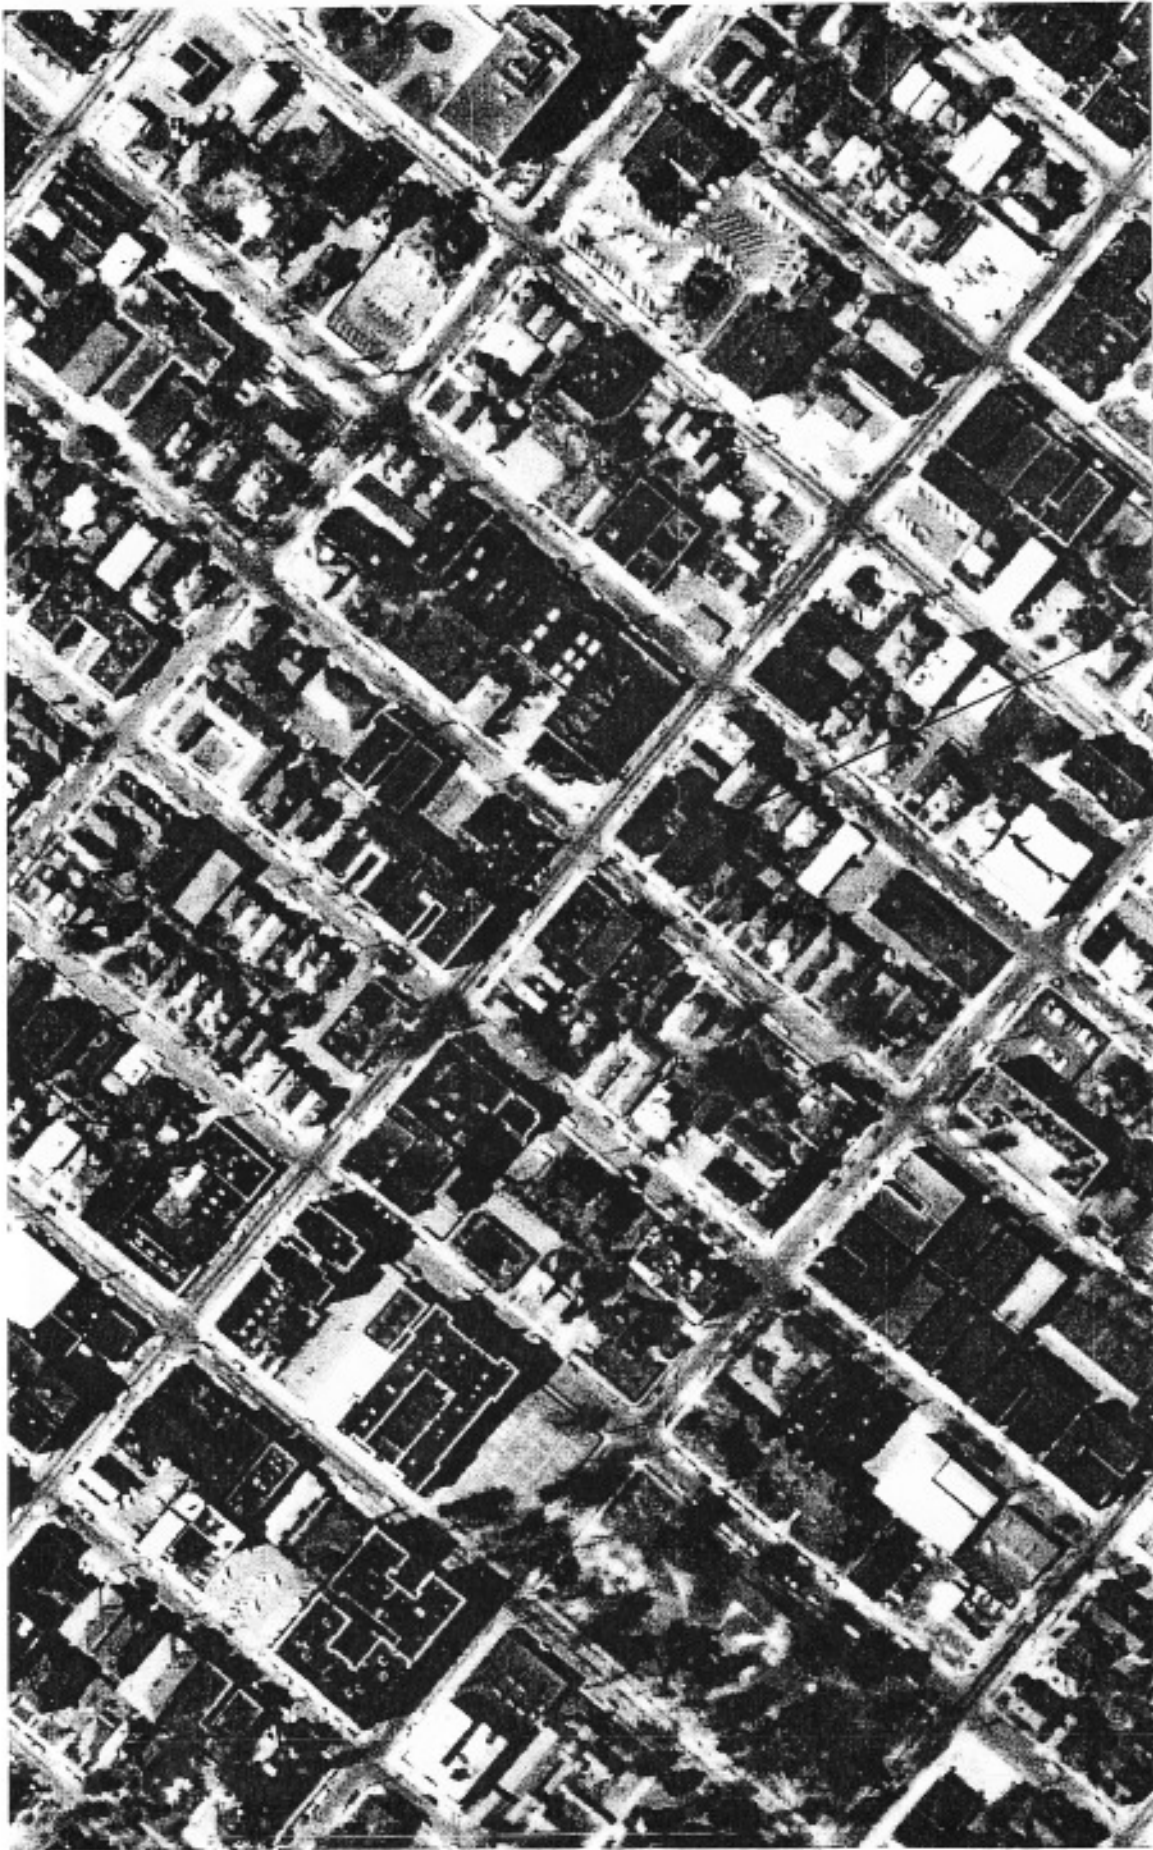
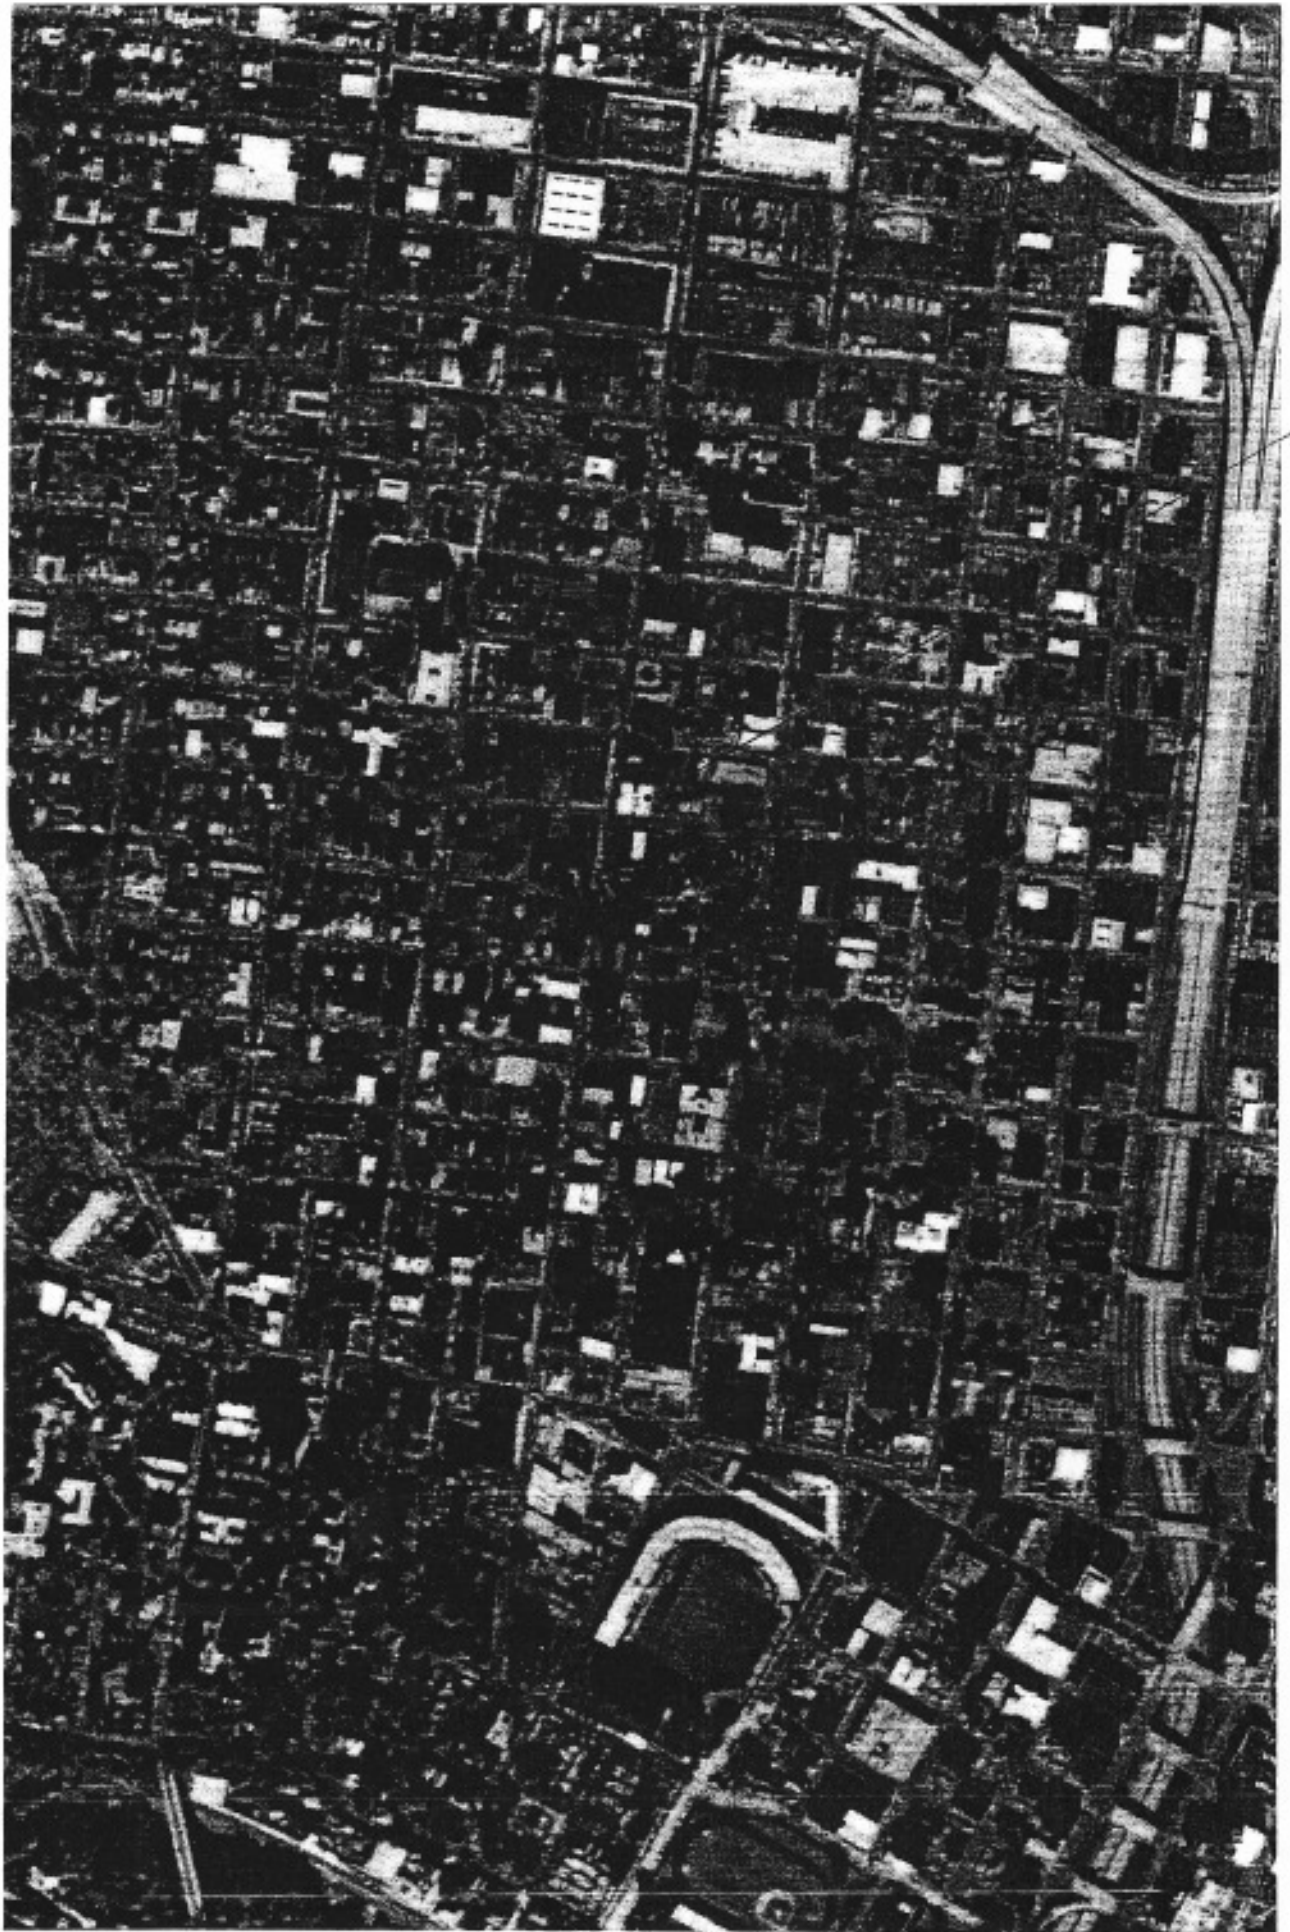
Historical records of this area were found through aerial photographs from the National Geologic Survey and the Corps of Engineers.

The historical perspective does not imply any concerns about operations or hazardous material carryovers from previous uses of this land. The type of observed facilities are not indicative of unusual environmental concern.
